Docket No. 217 – Development and Management Plan Inspection

Northeast Utilities Service Company Certificate of Environmental Compatibility and Public Need for the construction of a 345-kV electric transmission line and reconstruction of an existing 115-kV electric transmission line between Connecticut Light and Power Company's Plumtree Substation in Bethel, through the towns of Redding, Weston, and Wilton, and to the Norwalk Substation in Norwalk, Connecticut.

Date: February 2, 2005

Location: 345kV XLPE Component

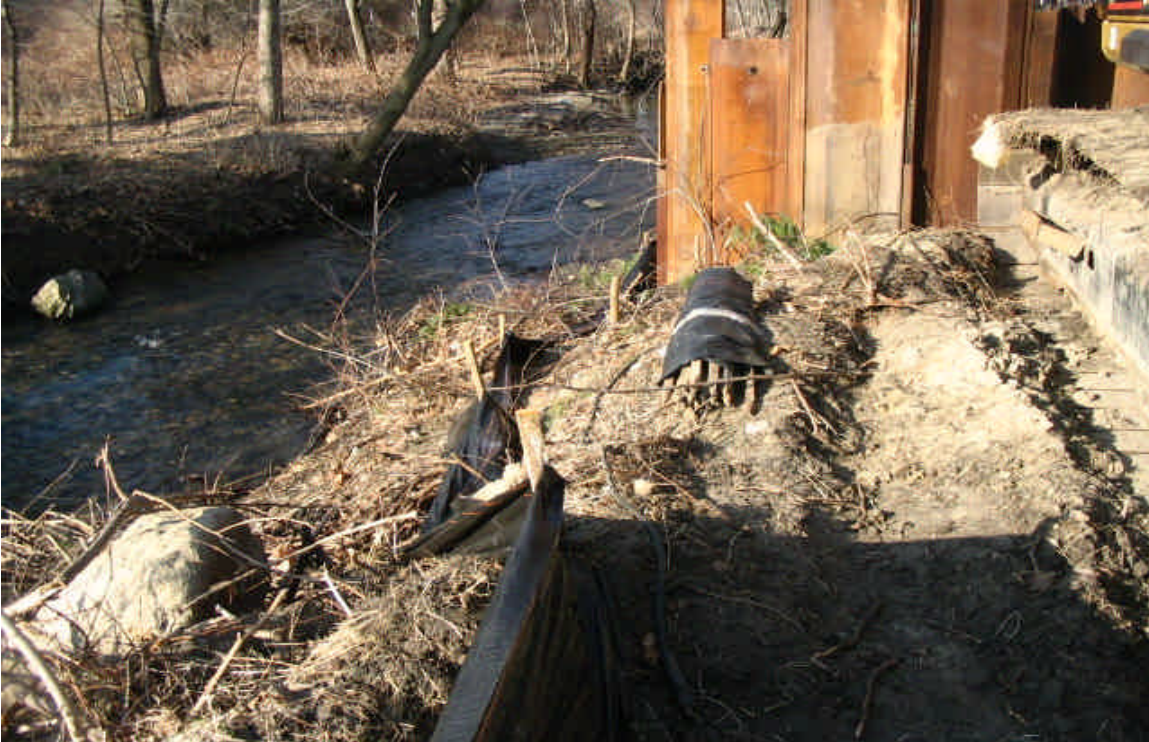
345kV XLPE (Jack and Bore): Photo shows the receiving side of the jack and bore with sheet piling installed. Silt fence was also in place here. Continue to maintain and extend if necessary.
2/2/06

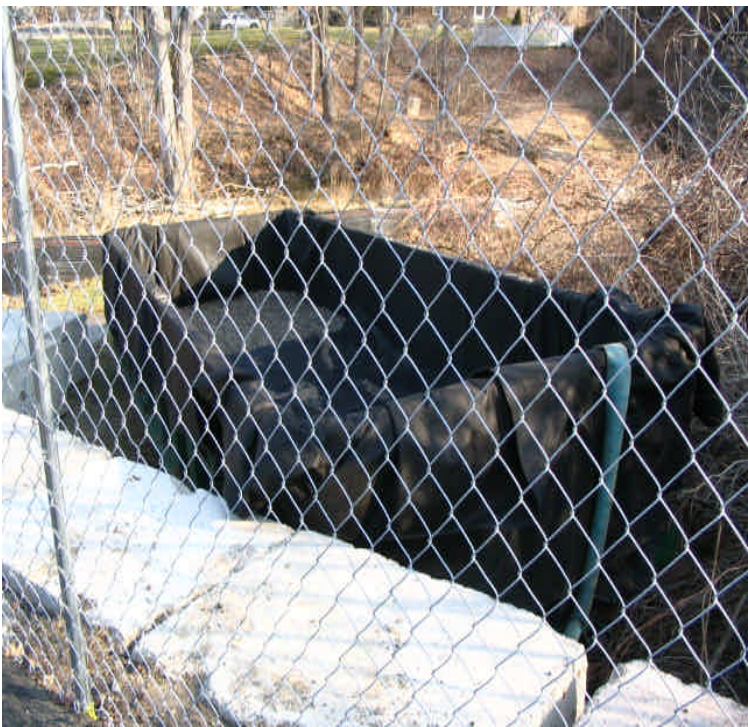
Photo on the left shows a well constructed dewatering pit with a filter bag in place. Monitor while in use to ensure it is sized properly. Photo on the right shows the stockpile on site. Controls are still down with potential sedimentation to the roadway but the pile will be removed soon. 2/2/06

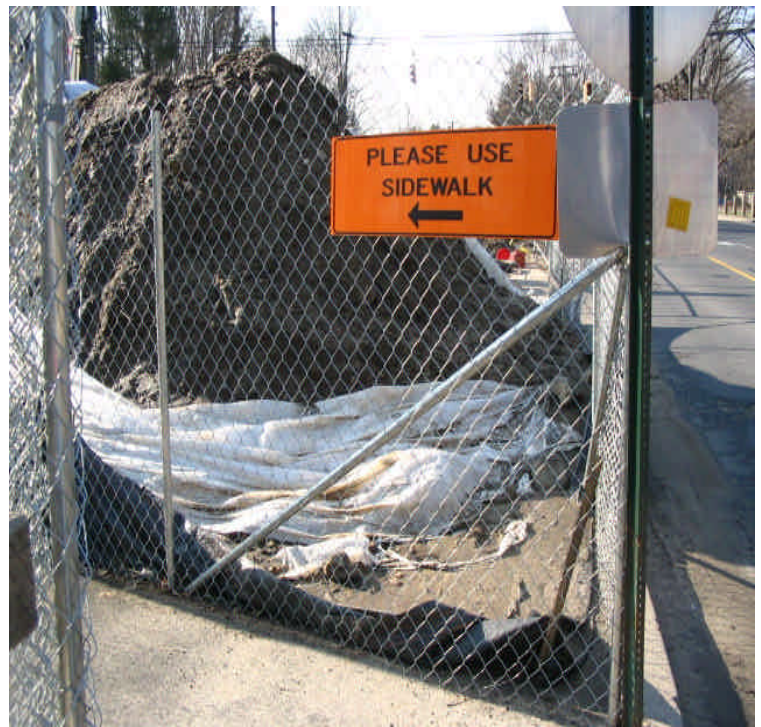
Areas of Inspection	Observation	Recommended Action
Erosion and Sediment Controls (includes inspection within 24 hours of a storm event)	<p>-The plastic covering slipped off the stockpile on site due to the previous heavy rains. Sedimentation was noted over the downed silt fence here and it had entered the street to some degree. 1/19-2/2/06</p> <p>- The silt fence adjacent to the river still appears to be well in place but run-off from a storm pipe has created a small gap. 1/4-2/2/06</p> <p>-Silt fence is in place on the receiving side as recommended. 1/26-2/2/06</p> <p>- A new dewatering pit was constructed. It is lined with filter fabric and includes a filter bag. 2/2/06</p> <p>-Hoyts Hill- Silt fence and haybales were well installed along the line of clearing in preparation for trenching. 2/2/06</p>	<p>-Contractors stated the pile would be removed from site shortly. If it remains, repair the silt fence at its base or install haybales here. 2/2/06</p> <p>- Place a haybale here if feasible in order to provide some filtration. 1/12-2/2/06</p> <p>-Continue to monitor and maintain and extend to provide further coverage if necessary. 1/26-2/2/06</p> <p>- The pit looks well constructed. Monitor while in use to be sure it has proper capacity. 2/2/06</p> <p>- Erosion controls are well in place, continue to monitor and maintain. 2/2/06</p>

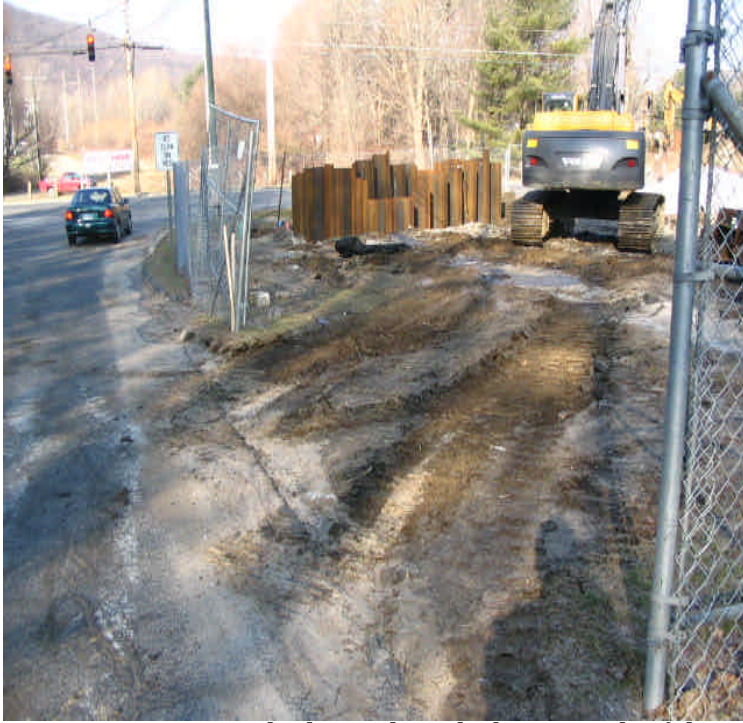
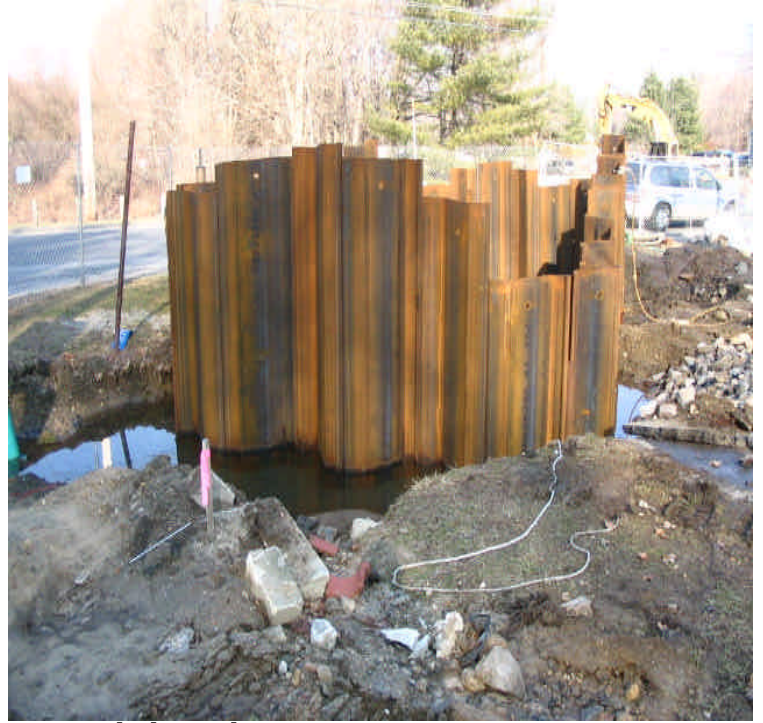
Both photos show the bore pit side of the operation with sheet piling. Excavation is going to begin soon on the bore pit and dewatering will be necessary at that time. 2/2/06

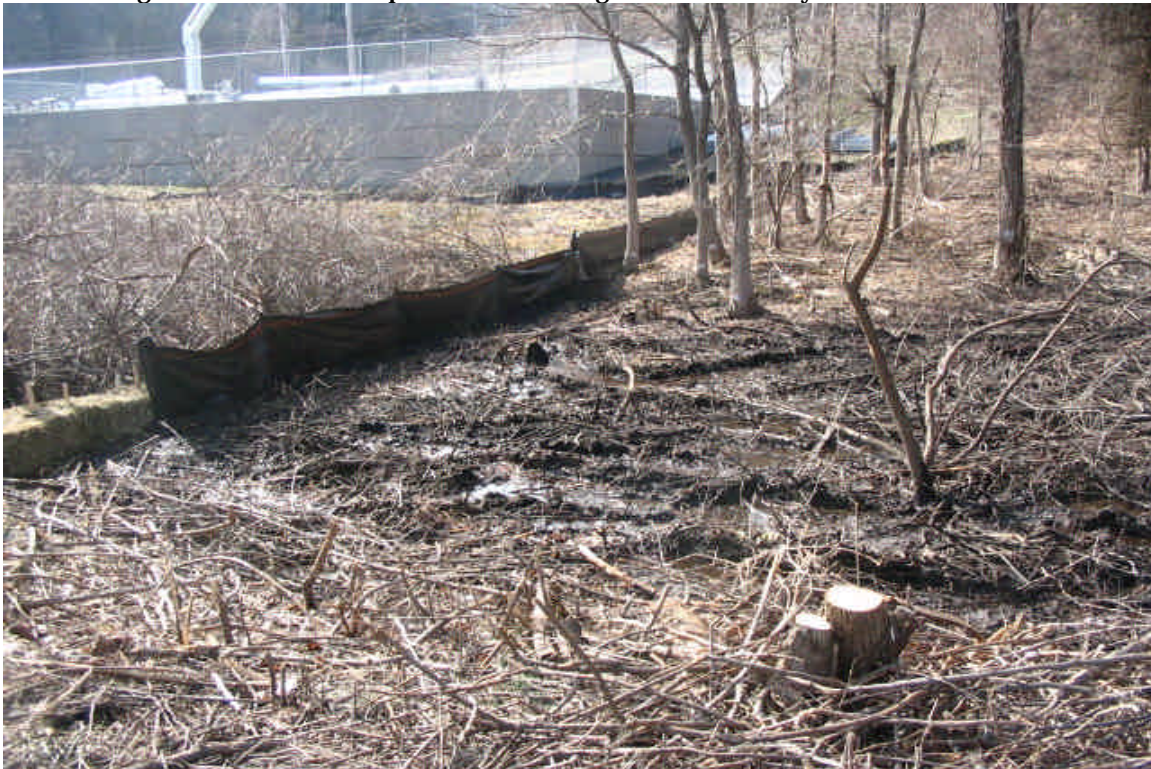
Hoyts Hill: Clearing is underway for a section of XLPE to connect to the Hoyts Hill Transition Station. Good erosion controls are in place and either mats or fabric and stone crossings will be installed to support the equipment that need to access the wetland. 2/2/06

Areas of Inspection	Observation	Recommended Action
	Hoyts Hill transition station where the XLPE will be connecting. Several trees remain to be cleared. 1/26-2/2/06	continue clearing. Trees should be skidded out on the crossings or towards the transition station to avoid ruts. 2/2/06
Dewatering	-Dewatering had not begun at this time but a well lined pit with a filter bag had been constructed at the jack and bore. Excavation and resulting dewatering is expected to begin shortly. 2/2/06.	-Monitor the pit for appropriate capacity. It looks well constructed. 2/2/06.
Blasting	- No blasting is occurring at this work area.	- None at this time.
Spills and Material Storage	. - Equipment was in place at the receiving pit immediately adjacent to the stream. Equipment should be stored overnight up to 100ft or as far from resource areas where practicable. 1/19-2/2/06	- Continue to keep all vehicles maintained well (i.e. no apparent fluid leaks) if they will be used or stored on site. - The contractors should remain vigilant about securing and handling fuel and all other material containers due to the sensitivity of the area. - Report spills immediately, even if they are being controlled. - Any fuels and agents not in use should be covered and stored before leaving for the day.
